[Freefall and Building 7 on 9/11](#)

**Freefall and Building 7 on 9/11**

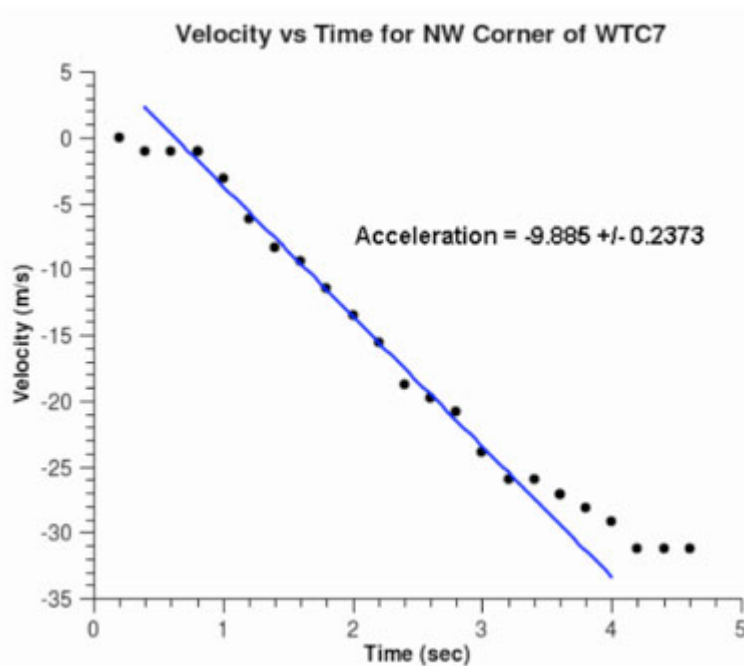
Velocity vs Time for NW Corner of WTC 7

After the east penthouse collapsed, several seconds elapsed, then the west penthouse began to collapse, at nearly the same time the roofline of the building developed a kink near the center, then all support across the entire width of the building was suddenly removed, a vertical swath of windows under the west penthouse were simultaneously blown out, the building suddenly went limp, and (within a fraction of a second) it transitioned from full support to freefall. I am not using the term "freefall" loosely here. I used a video analysis tool to carefully measure the velocity profile of the falling building using CBS video footage from a fixed camera aimed almost squarely at the north wall. A video detailing this measurement is available at [YouTube/user/ae911truth](https://www.youtube.com/user/ae911truth). I calibrated my measurements with the heights of two points in the building provided in the NIST Building 7 report released in August 2008, so I know the picture scale is good. My measurements indicate that with sudden onset the building underwent approximately 2.5 seconds of literal freefall. This is equivalent to approximately 8 stories of fall in which the falling section of the building encountered zero resistance. For an additional 8 stories it encountered minimal resistance, during which it continued to accelerate, but at a rate less than freefall. Only beyond those 16 stories of drop did the falling section of the building interact significantly with the underlying structure and decelerate.

The recurrence of 5.4 seconds, even in a completely revised analysis, is very puzzling until you realize its context. NIST lead investigator Shyam Sunder told the audience in the August 26, 2008 Technical Briefing that their computerized collapse model had predicted the collapse down to the 29th floor level would take 5.4 seconds, well beyond the 3.9 seconds required for freefall. From the events at the Technical Briefing it appears that a team headed by structural engineer John Gross dutifully fabricated a 5.4 second observation to exactly match the prediction. Anyone with any experience in laboratory measurement would have expected some amount of uncertainty between the prediction and the measurement. They would have been doing extremely well to come up with a computer model that would predict the collapse time within 10%. But no...their measurement exactly matched the prediction to the tenth of a second. Keep in mind that their computer model was constructed in the absence of the actual steel, which had long since been hauled away and destroyed. According to NIST's records, none of the steel from Building 7 remains. (Pause and ponder that fact for a moment. Anyone who has watched CSI knows the importance of preserving the physical evidence in a crime scene. Destroying a crime scene is in itself a crime, yet that is exactly what happened in the aftermath of 9/11, and it happened over the loud protests of the firefighters and others who had a stake in really finding out the truth.) Back to our story. NIST's computer model predicted 5.4 seconds for the building to collapse down to the level of the 29th floor. John Gross and his team found the time the roofline reached the 29th floor, then picked a start time exactly 5.4 seconds earlier to give a measurement that matched the model to the nearest tenth of a second. They took their start time several seconds prior to the actual start of freefall when nothing was happening. The building was just sitting there, with the clock running, for several seconds. Then it dropped, with sudden onset, and continued for 2.5 seconds of absolute freefall.
